Final  
**DECISION DOCUMENT**  
**UST SITE 301**

117th Refueling Wing  
Alabama Air National Guard  
Birmingham Airport  
Birmingham, Alabama

January 1997

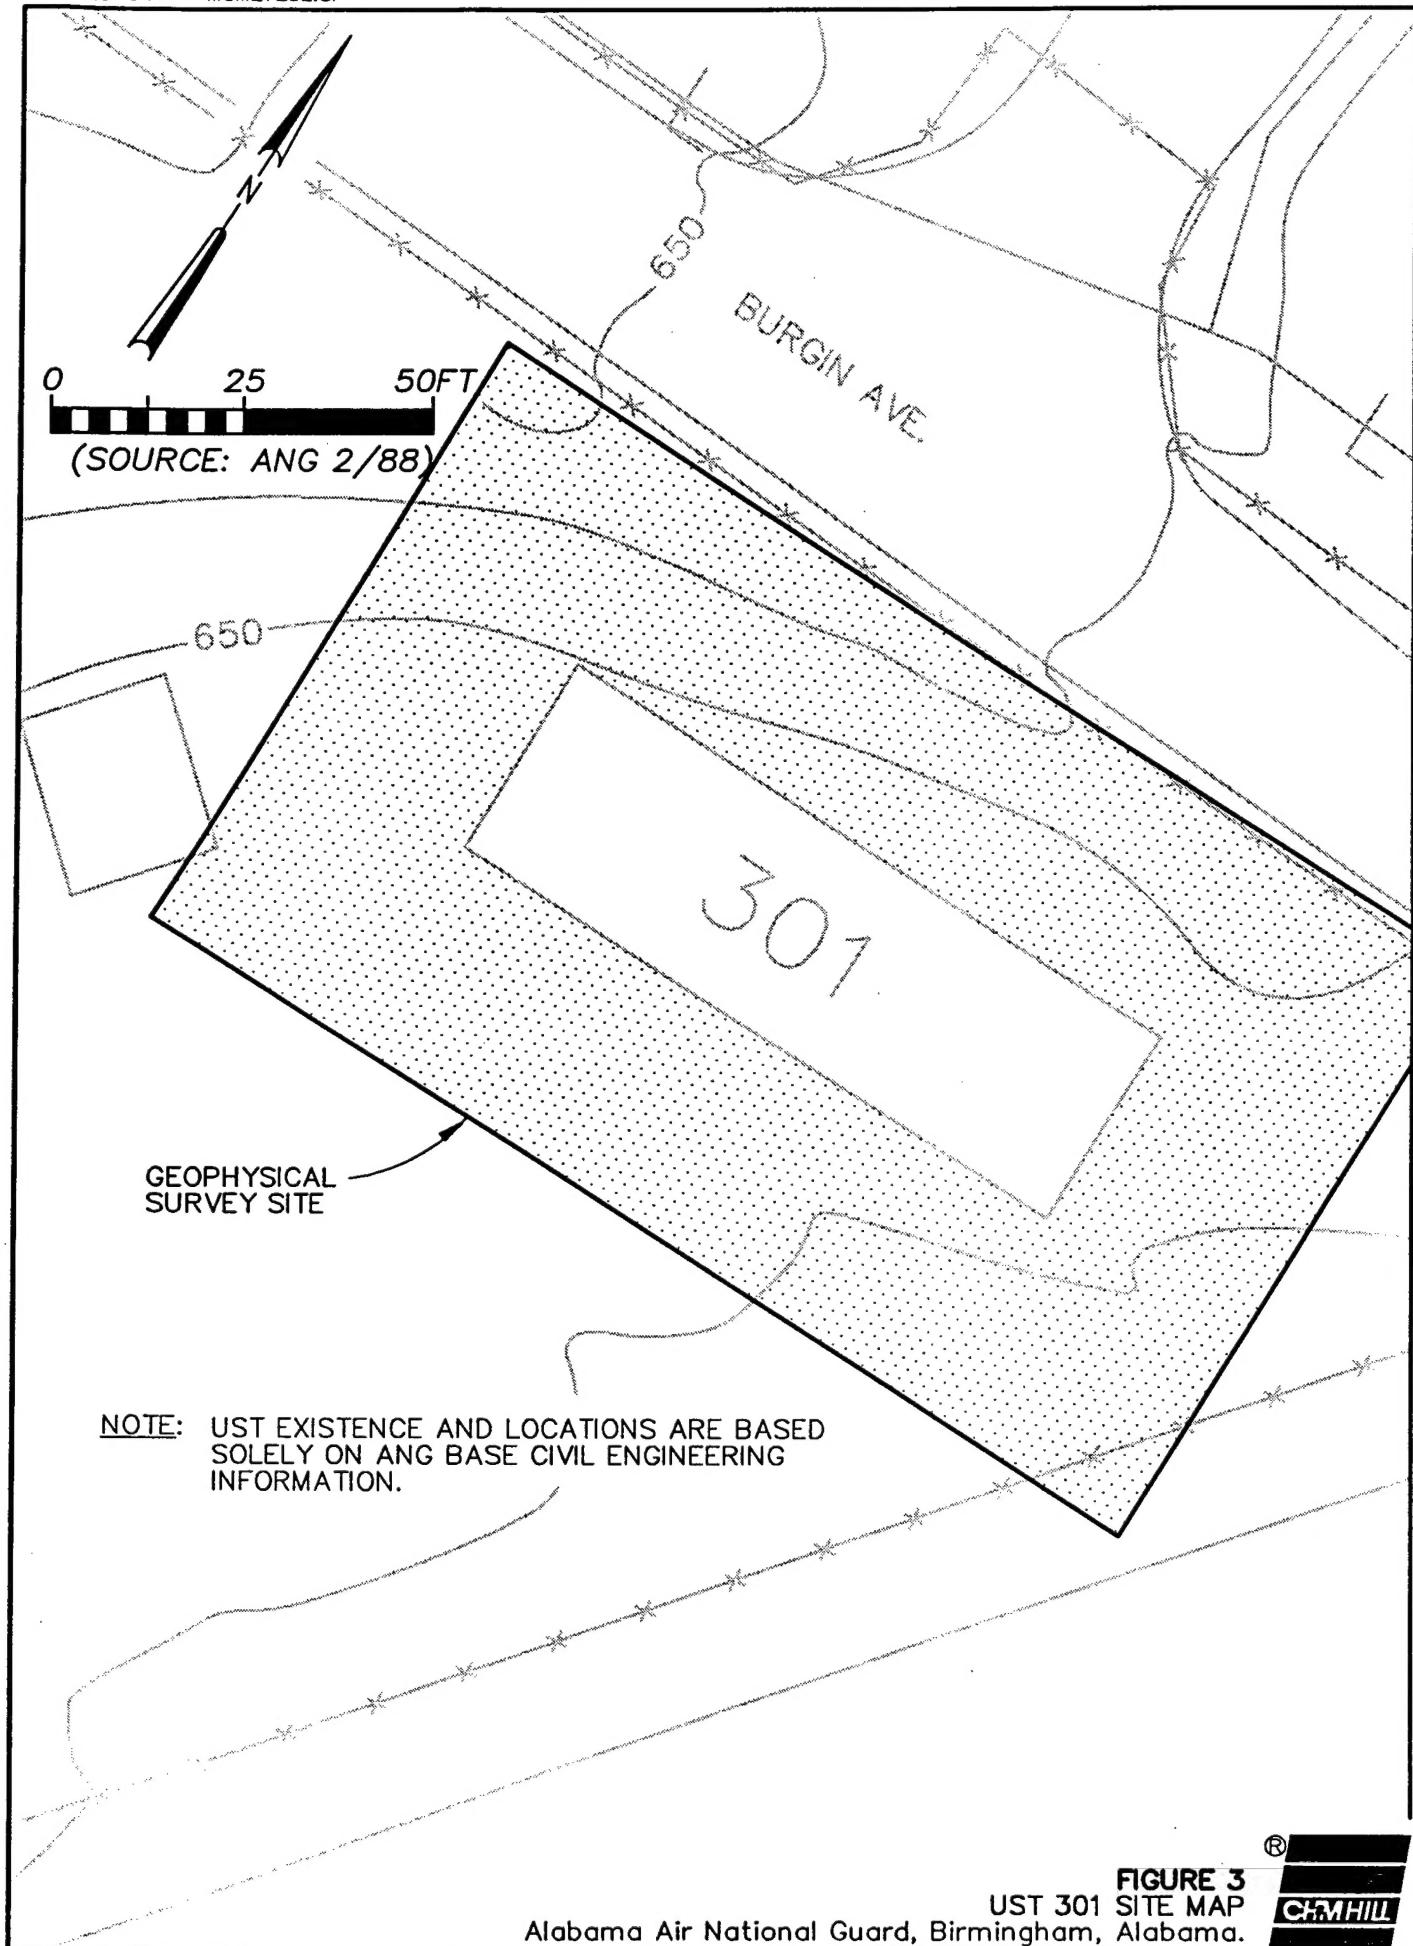
**FIGURE 3**  
UST 301 SITE MAP  
Alabama Air National Guard, Birmingham, Alabama.

UST 301 was indicated to be a butane tank based on information found during the initial investigation of the AANG facility. Figure 3 shows the UST 301 site map.

During the Tank Survey Task to identify the location and sizes of the tank, magnetic devices and Ground Penetrating Radar (GPR) were used to identify tank boundaries and sizes. One area was found during this task in the suspected UST area and was further investigated using a hand auger. Hand augering determined that the results of the GPR survey were a result of feedback from shallow rock formations found near the ground surface. An asphaltic cement slab also is located in the suspected area of the UST at the north end of Building 301. Investigation was not conducted under this pavement slab.

Past operations at the UST 301 site led to this investigation because of possible soil and water contamination. A field survey task used to identify the UST location and size did not reveal the presence of a UST at this site. Numerous utilities exist in this area and some would have been placed either overlying or very near the pre-existing tank. A slab on which a large air conditioning unit is mounted is also in the area of concern. It is probable that if a tank were located here, it is 1) under the A/C slab, 2) was removed when the boiler was decommissioned, or 3) was removed during the burial of utility lines or construction of the A/C slab. Because this tank was known to contain butane, which is gaseous at atmospheric temperature and pressures, the possibility of contamination resulting from the degradation of the tank is minimal. It is recommended, therefore, that no further study of this site be performed.

Because no UST was found, it is recommended that this site be removed from further IRP activities and that no further action be required.
